**THE EFFECTS OF ENVIRONMENT ON THE INTERLAMINAR SHEAR
PERFORMANCE OF AN OXIDE/OXIDE CERAMIC MATRIX COMPOSITE AT
ELEVATED TEMPERATURE**

THESIS

AFIT/GAE/ENY/07-J11

AIR FORCE INSTITUTE OF TECHNOLOGY

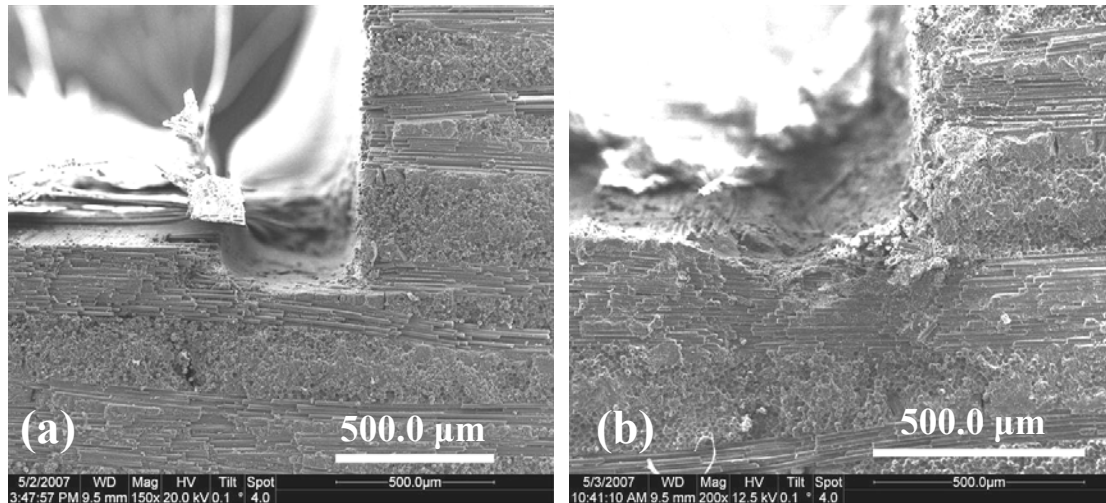
Figure 64: (a) Notch of the specimen tested at -6.5 MPa in air for 100 h at 1200°C. (b) Notch of the specimen tested at -4.0 MPa in steam for 100 h at 1200°C.

The differences in the side views of the specimen crept for 100 h in air and the specimen crept for 100 h in steam indicate the corrosive action of the steam (See Figure 64). The notch of the specimen crept in air is very smooth and clean when compared to the specimen crept in steam. There appears to be some sort of corrosive layer on the side of the specimen in steam that is not present in air. This area of the notch is not under any significant amount of load and thus corrosion is due to the presence of steam at the temperature of 1200°C.

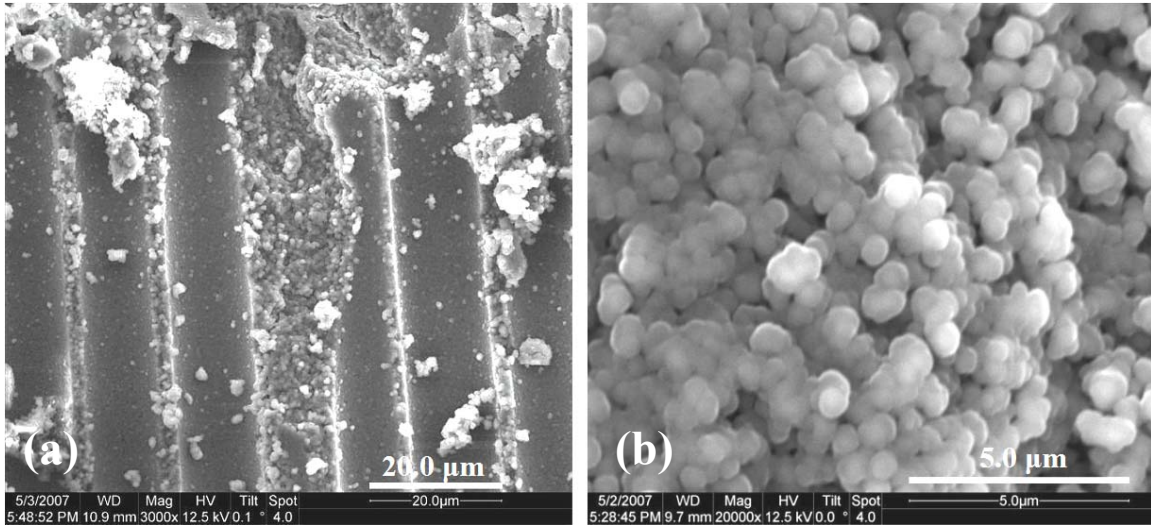
Figure 65: (a) Fracture surface of a virgin specimen exposed to neither temperature nor steam environment. (b) A close-up view of the middle portion of (a) showing matrix particle size and porosity.

In order to determine the various effects that creep and environment have on the matrix of N720/A, SEM micrographs of a virgin specimen were taken. Figure 65 (a) shows that there is still the presence of troughs on the fracture surface even though the specimen was never exposed to temperature or environment. The ability of the troughs to retain their shape even after failure indicates there is already a lack of porosity in the matrix that is bonded to the fibers. The matrix grains as seen in Figure 65 (b) are on the order of $\sim 0.5 \mu\text{m}$. There are clear differences in porosity between the troughs and the middle of the image where the matrix was destroyed. The presence of the fibers must affect the grain growth of the matrix during sintering.

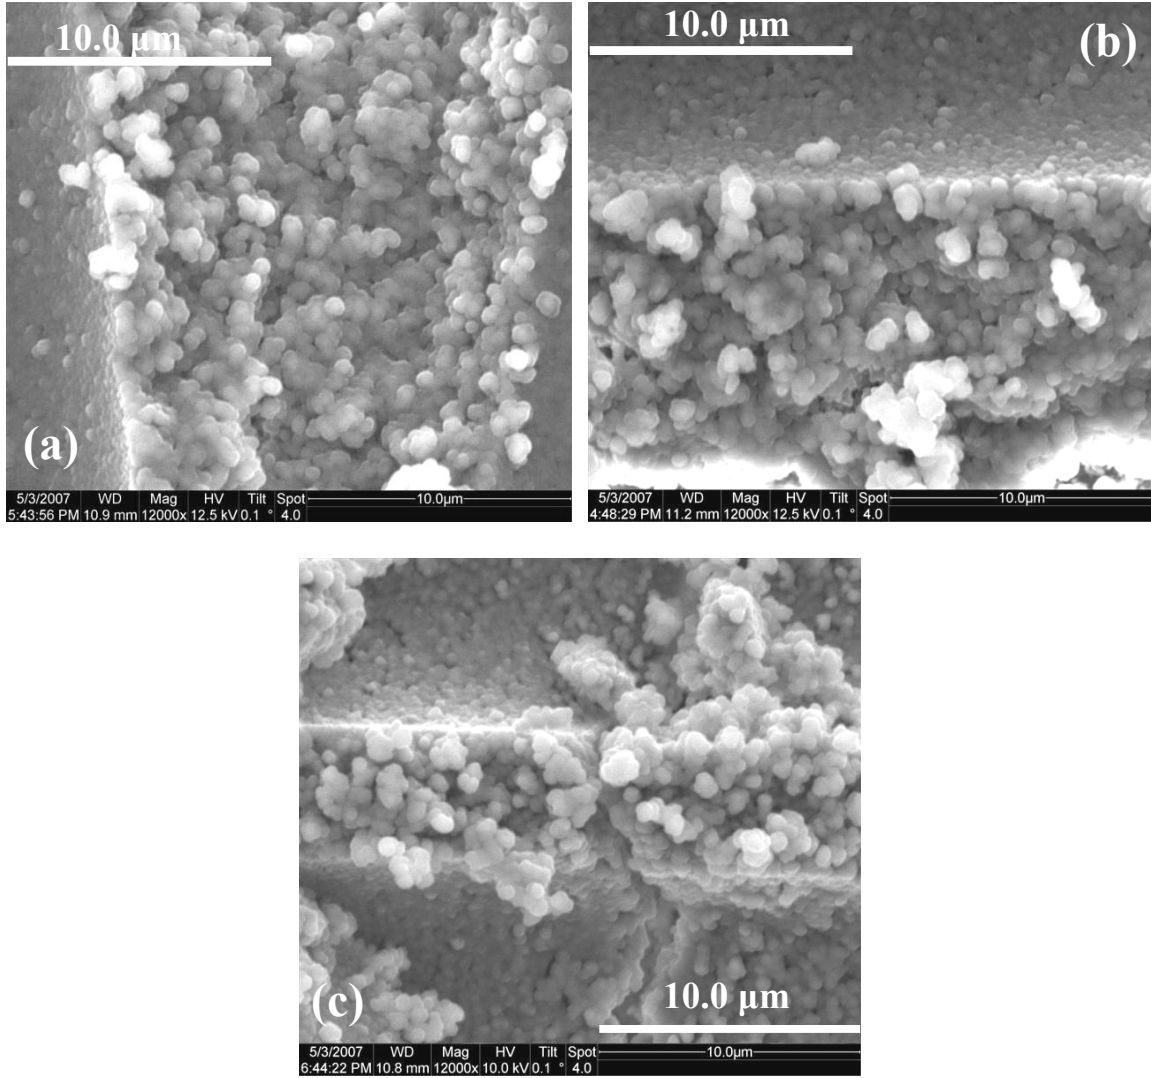
Figure 66: Close-up of the matrix of (a) a virgin specimen, (b) the specimen tested in monotonic compression to failure in air at 1200°C, and (c) the specimen tested at -6.5 MPa creep for 100 h in air at 1200°C.

Close-up views of the matrix for a virgin specimen, a specimen tested monotonically in air, and a specimen crept in air for 100 h are shown in Figure 66. The matrix particle size appears to be the same for the virgin specimen and the specimen tested in monotonic compression to failure at 1200°C in air. This is reasonable since the specimen was only exposed to temperature for approximately 15 minutes before failure. The matrix particle size for the specimen crept at -6.5 MPa for 100 h in air appears to be somewhat larger than that of the virgin specimen, however, only through the use of a transmission electron microscope (TEM) can this be confirmed. There also appears to be a considerable amount of large formations of matrix clumps as shown in Figure 66 (c).

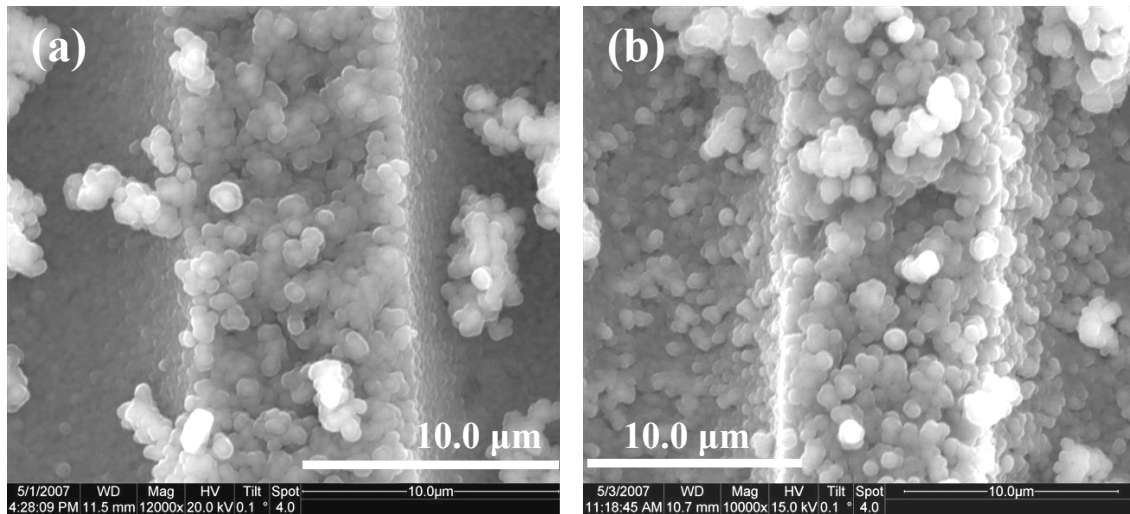
Figure 67: Close-up of the alumina matrix of (a) the specimen that survived for 5.7 h of creep at -6.5 MPa in steam at 1200°C and (b) the specimen that survived 100 h of creep at -4.0 MPa for 100 h in steam at 1200°C.

The effects of steam on the matrix of N720/A are evident based upon the mechanical response of the composite in a steam environment as discussed above. The matrix grains seen in Figure 67 (a) are those of the specimen tested in compressive creep at 6.5 MPa in steam at 1200°C. The alumina grains appear much more rounded than those of the matrix of the specimen tested in creep at the same interlaminar shear stress level in air. Figure 67 (b) is of the matrix of the specimen tested in creep with an interlaminar shear stress of -4.0 MPa in steam at 1200°C for 100 h. This specimen was exposed to steam for a much longer duration than that of Figure 67 (a). The matrix grains in the troughs of Figure 67 (b) create a much rougher surface than those in Figure 67 (a). Most of the troughs of the specimen tested at -4.0 MPa creep were as smooth as in the specimen tested at -6.5 MPa creep in steam, however, the troughs shown in Figure 67 (b) most likely have undergone additional corrosion due to local stress levels and the presence of a moist environment.

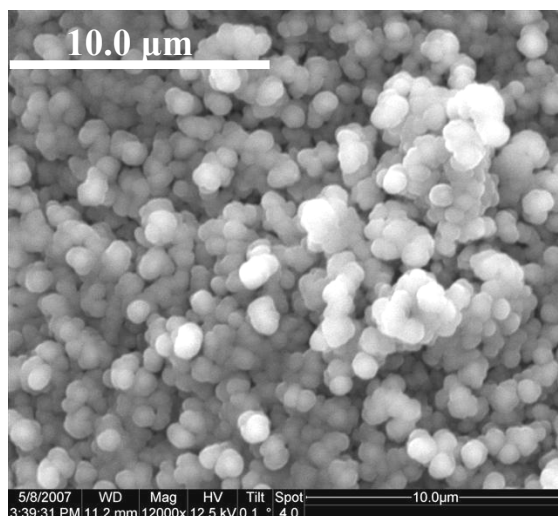
Figure 68: Close-up of the matrix of the specimen tested in monotonic compression to failure after being aged in steam for 24 h at 1200°C.

The micrograph shown in Figure 68 is of the matrix of the N720/A specimen aged in steam at 1200°C for 24 h prior to compression to failure. The matrix grain size is still very small and the porosity of the matrix is still evident. It should be recalled that this specimen failed at an interlaminar shear stress nearly equal to the as-processed specimen and only exhibited slightly higher strain at failure. It seems reasonable that the matrix should still be nearly as porous as the as-processed specimen due to the short loading period. Since the matrix had 24 h of exposure to steam where corrosion likely took place, it would be interesting to view the matrix using a TEM for better clarity to determine the mechanisms damaging the matrix.

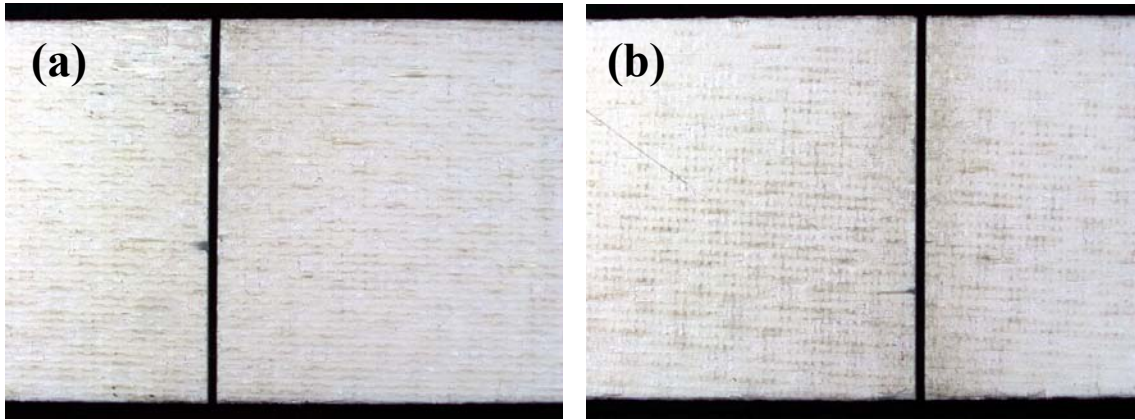
Figure 69: Notches of a typical specimen. (a) is from one side and (b) is from the other side.

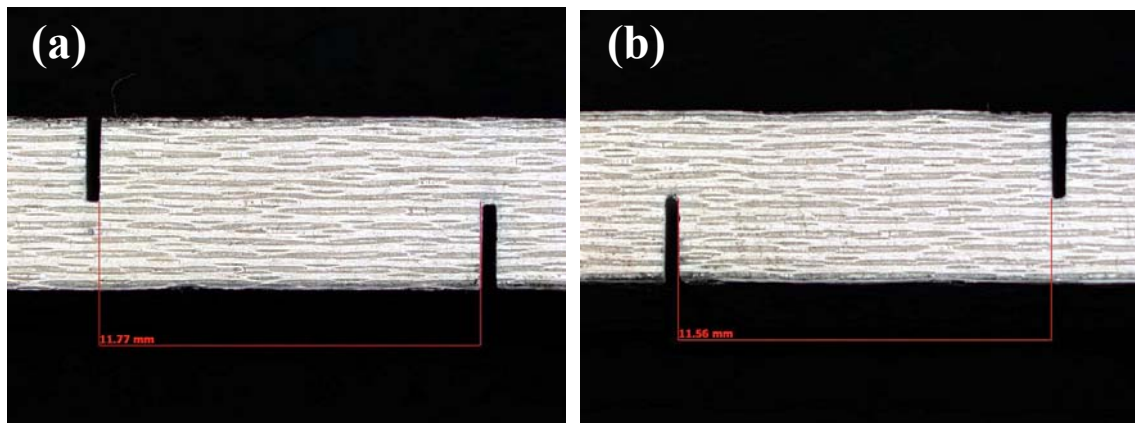
Figure 70: Side views of the notches of a typical specimen. Note the slight difference in distance between the notches. These specimens were still deemed sufficient for testing. (a) is from one side and (b) is from the other side.

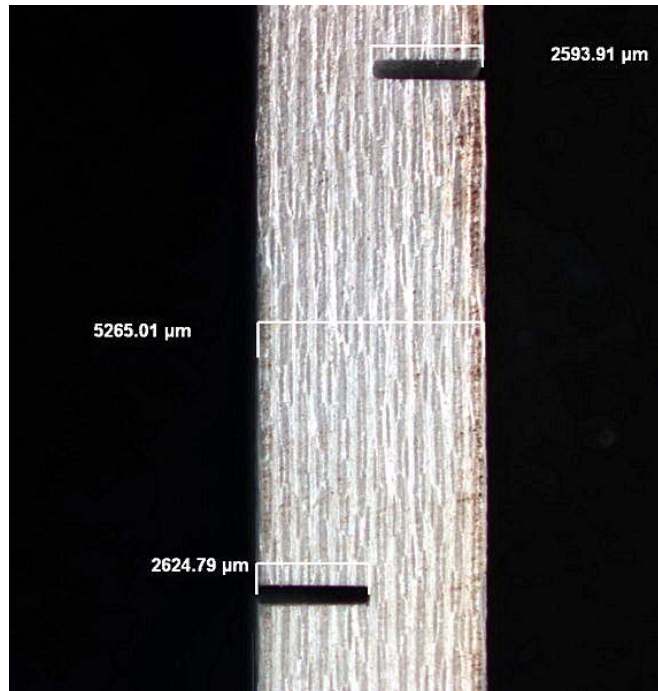
Figure 71: This figure shows a typical side view of a specimen with the depths of the notches and width of the specimen measured. Note the notch depths are practically the same and equal to half of the width of the specimen.

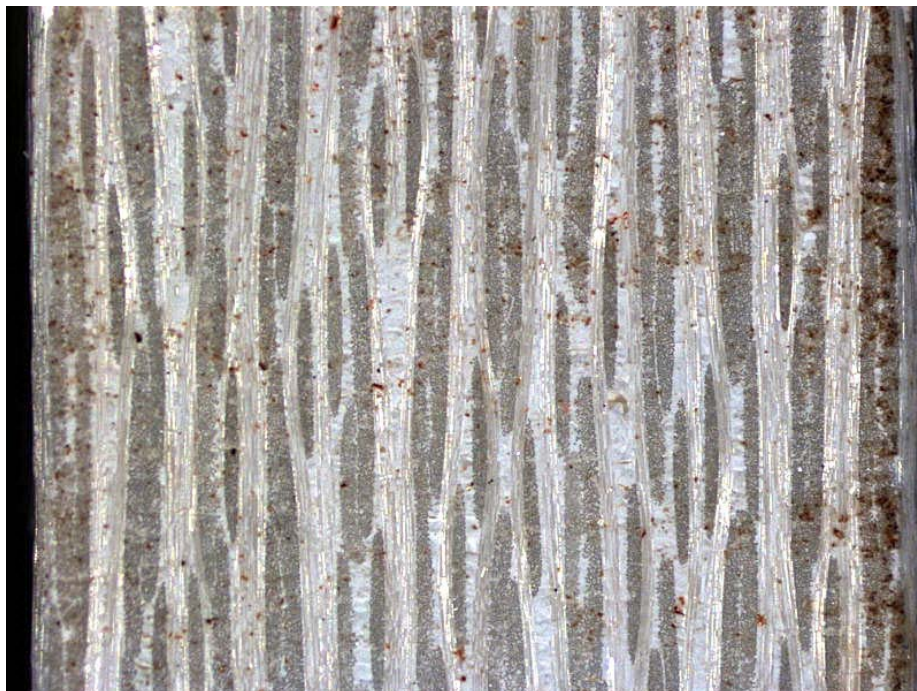
Figure 72: Close-up side view of the N720/A specimen used in this research.

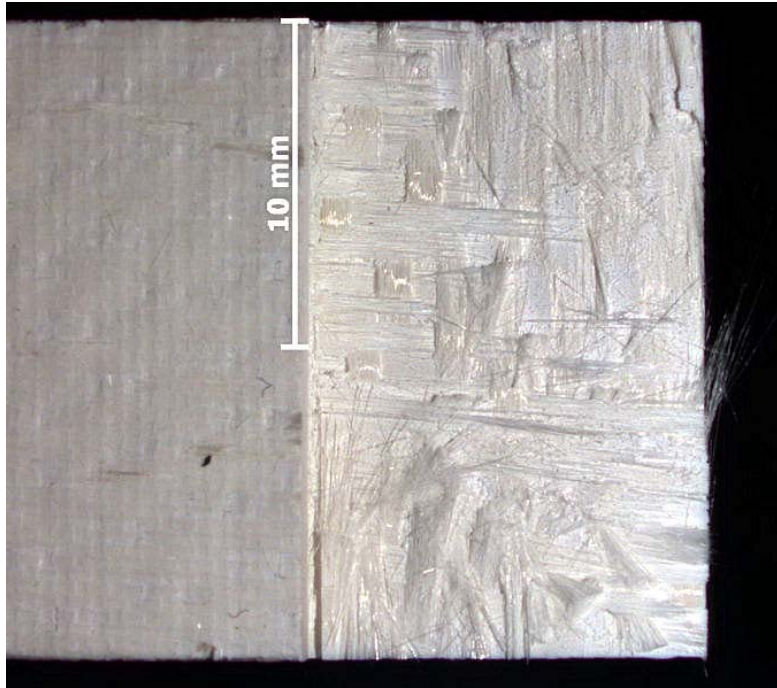
Figure 73: Fracture surface of N720/A specimen tested in tension to failure at 1200 °C in air, Piece A.

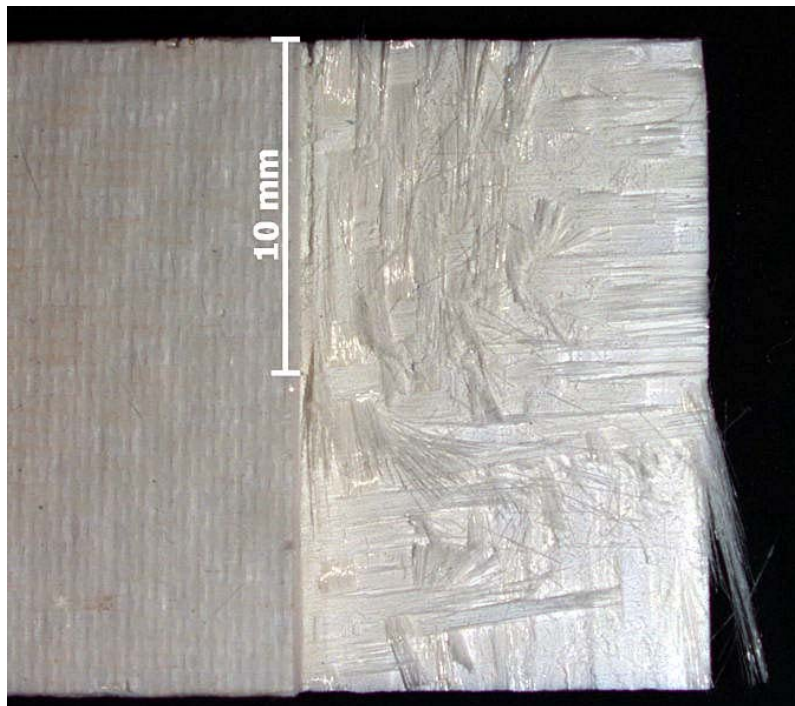
Figure 74: Fracture surface of N720/A specimen tested in tension to failure at 1200 °C in air, Piece B.

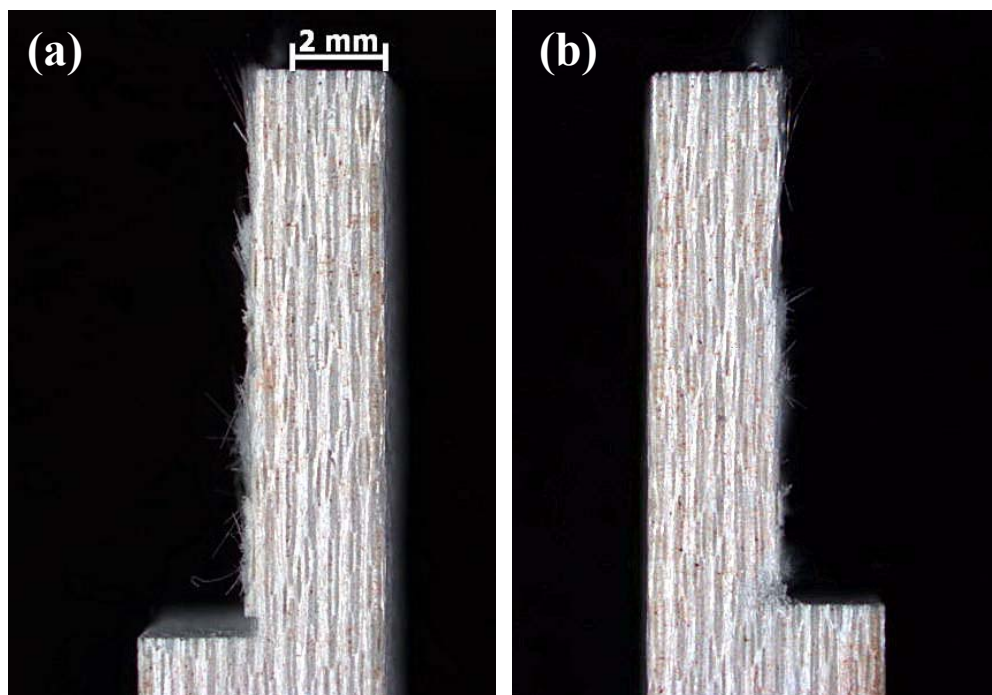
Figure 75: Side views of fracture surfaces of N720/A specimen tested in tension to failure at 1200 °C in air. (a) is of Piece A. (b) is of Piece B.

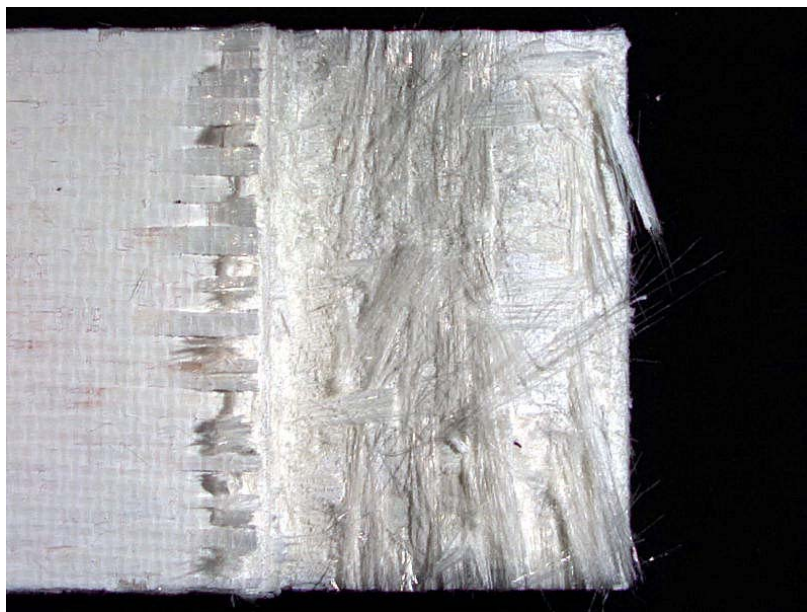
Figure 76: Fracture surface of N720/A specimen tested in compression to failure at 1200 °C in air. The other piece is shown in Figure 20.

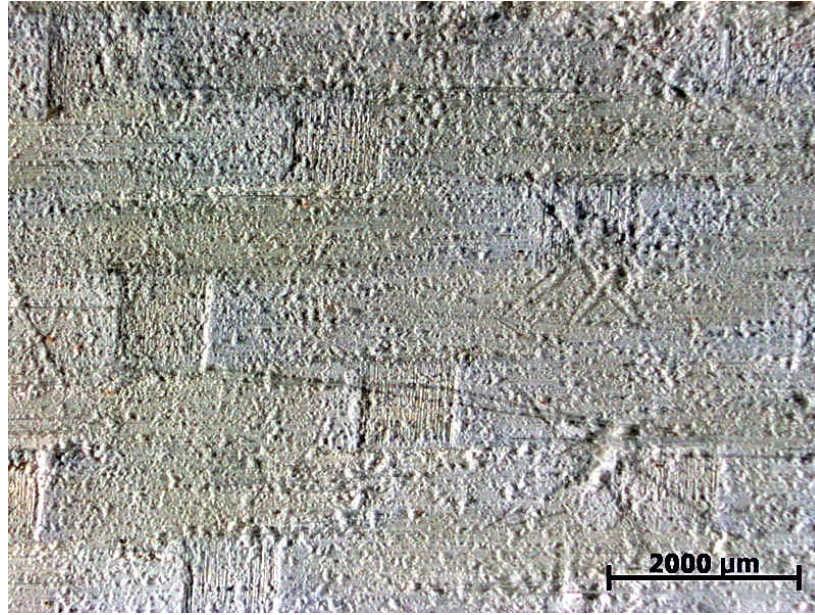
Figure 77: Close-up of the fracture surface of the specimen tested in compression to failure in air at 1200°C.

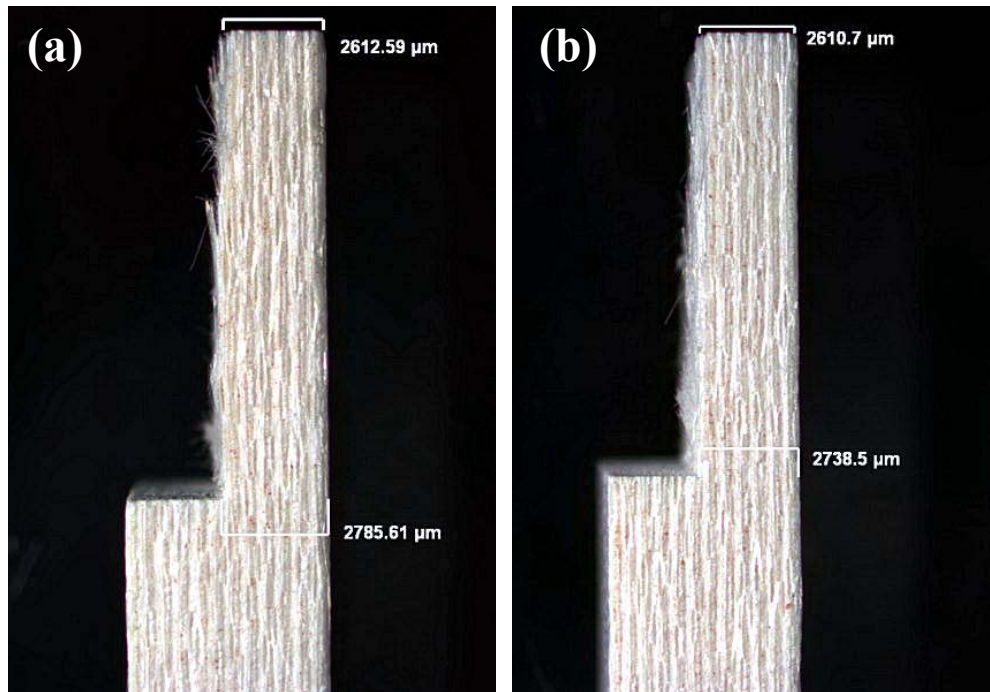
Figure 78: Side views of fracture surfaces of N720/A specimen tested in creep at -6.5 MPa at 1200 °C in air. (a) is of piece A. (b) is of piece B.

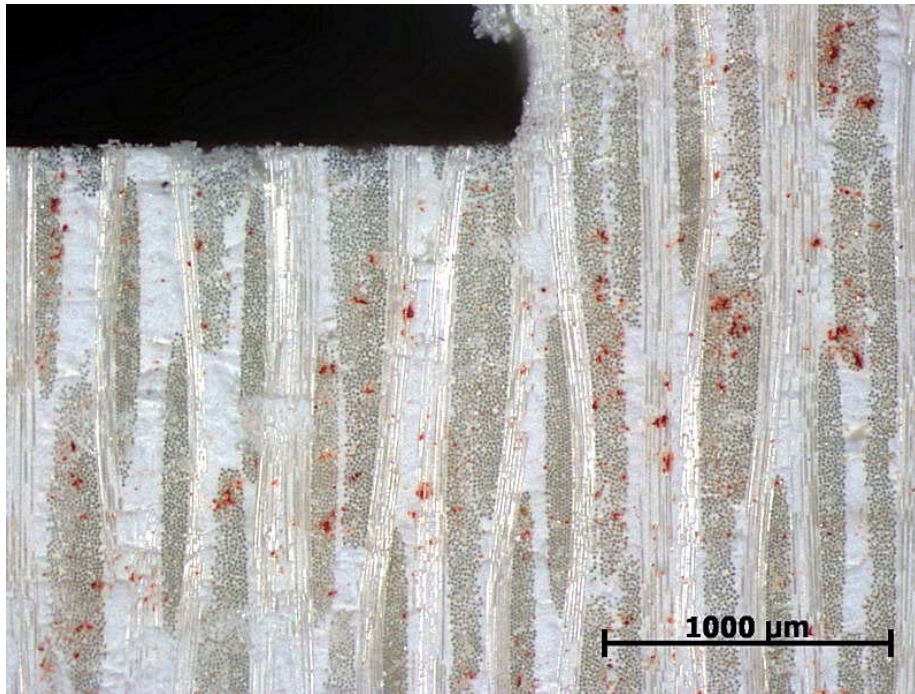
Figure 79: Side view of piece A of the N720/A specimen tested in creep at -6.5 MPa at 1200 °C in air.

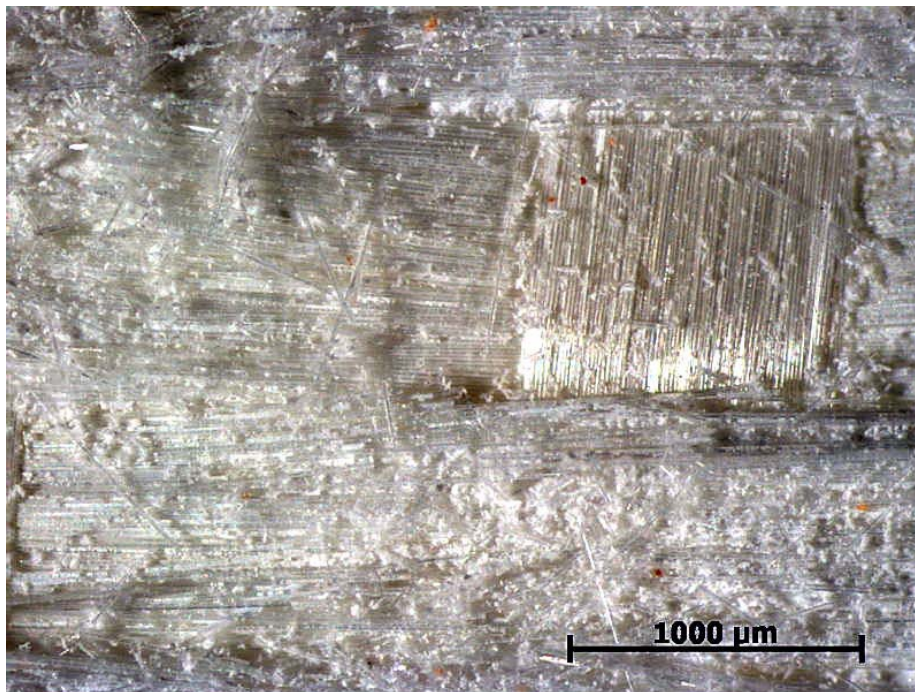
Figure 80: Close-up of piece A of the N720/A specimen tested in creep at -6.5 MPa at 1200 °C in air.

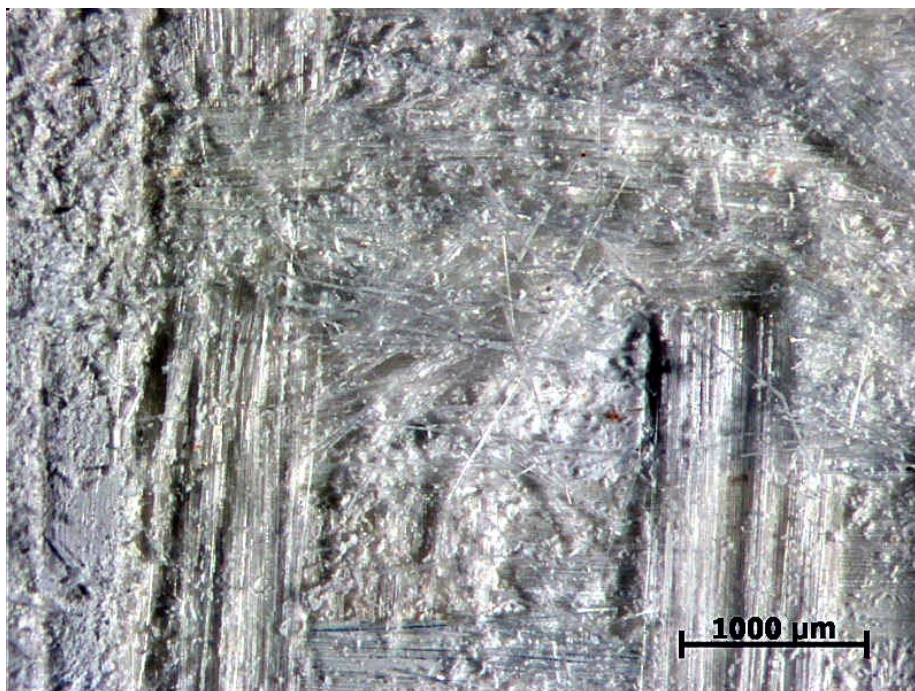
Figure 81: Close-up of piece A of the N720/A specimen tested in creep at -6.5 MPa at 1200 °C in air.

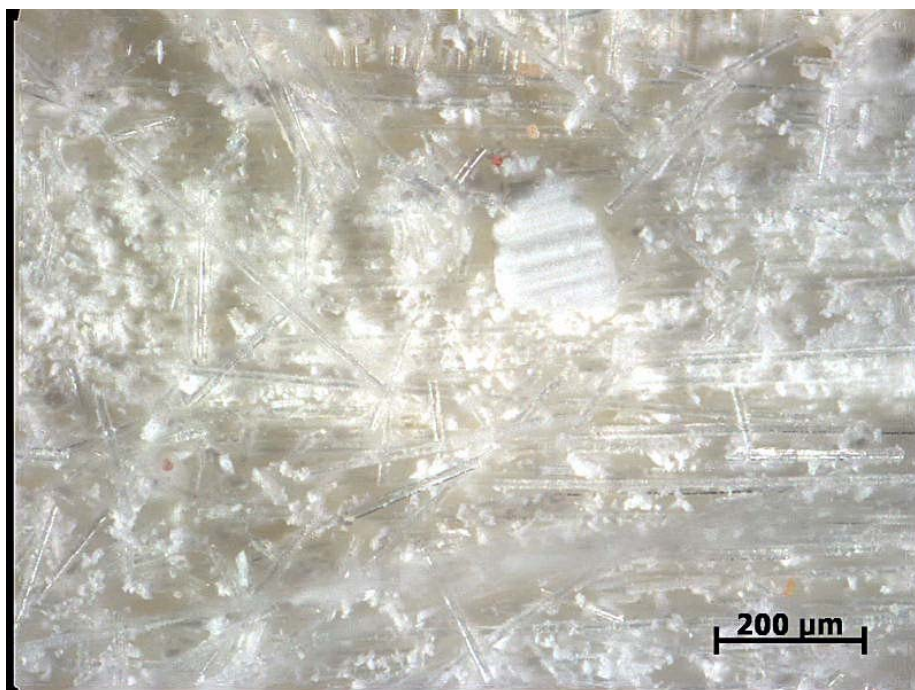
Figure 82: Close-up of piece A of the N720/A specimen tested in creep at -6.5 MPa at 1200 °C in air.

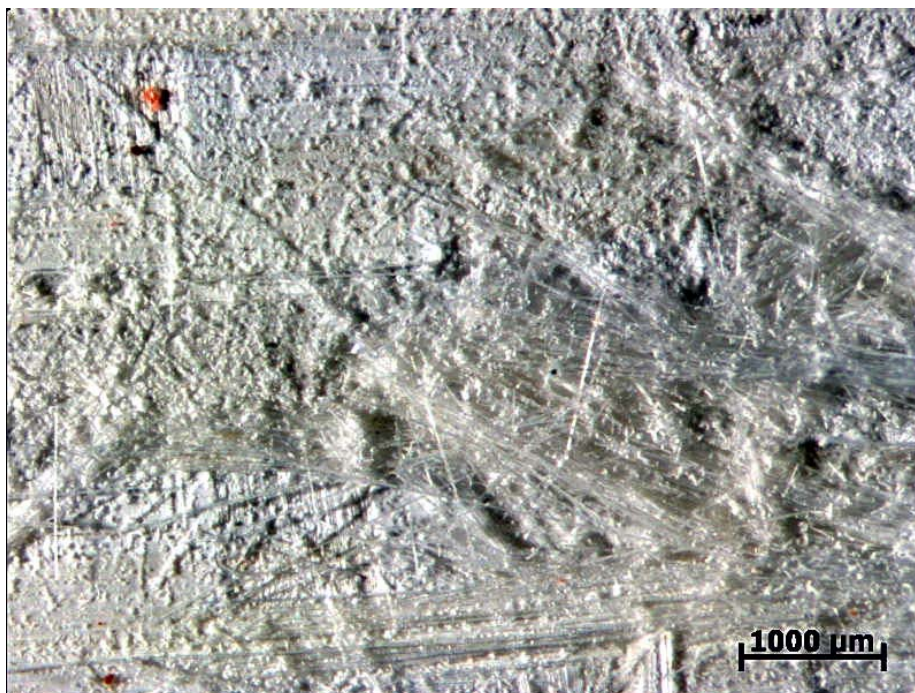
Figure 83: Close-up of piece B of the N720/A specimen tested in creep at -6.5 MPa at 1200 °C in air.

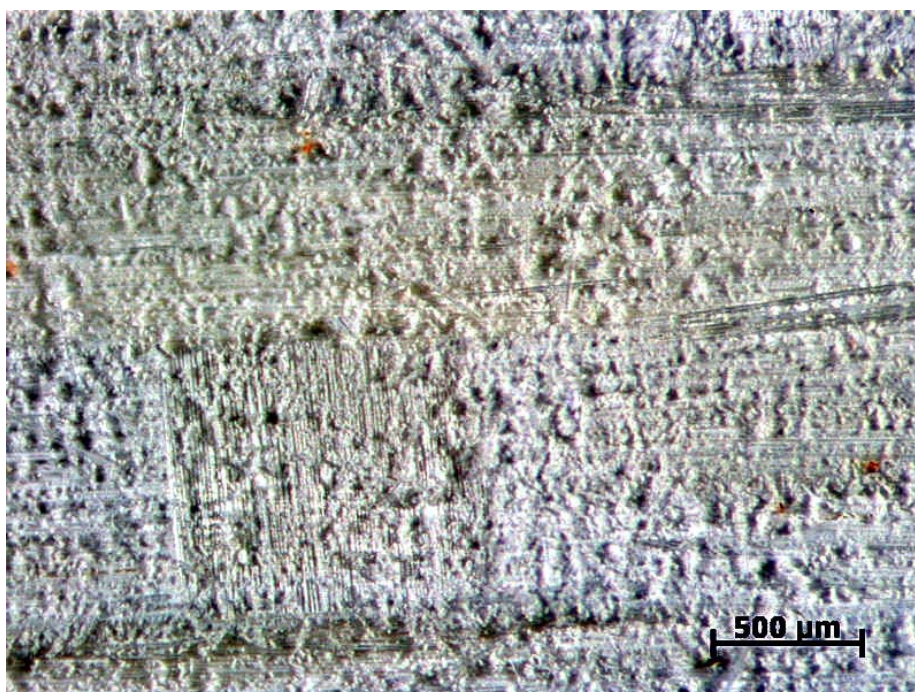
Figure 84: Close-up of piece B of the N720/A specimen tested in creep at -6.5 MPa at 1200 °C in air.

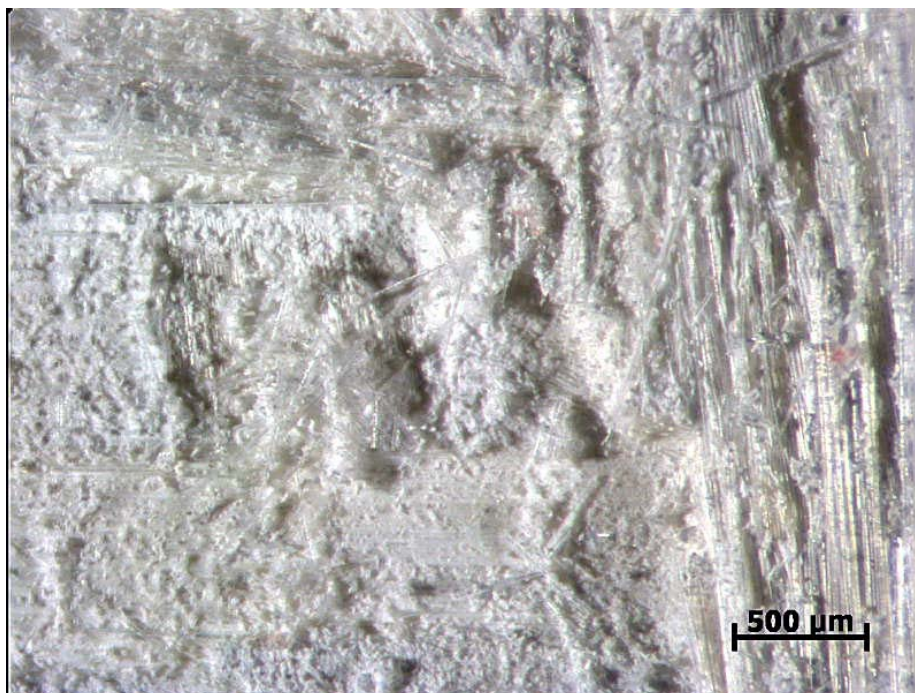
Figure 85: Close-up of piece B of the N720/A specimen tested in creep at -6.5 MPa at 1200 °C in air.

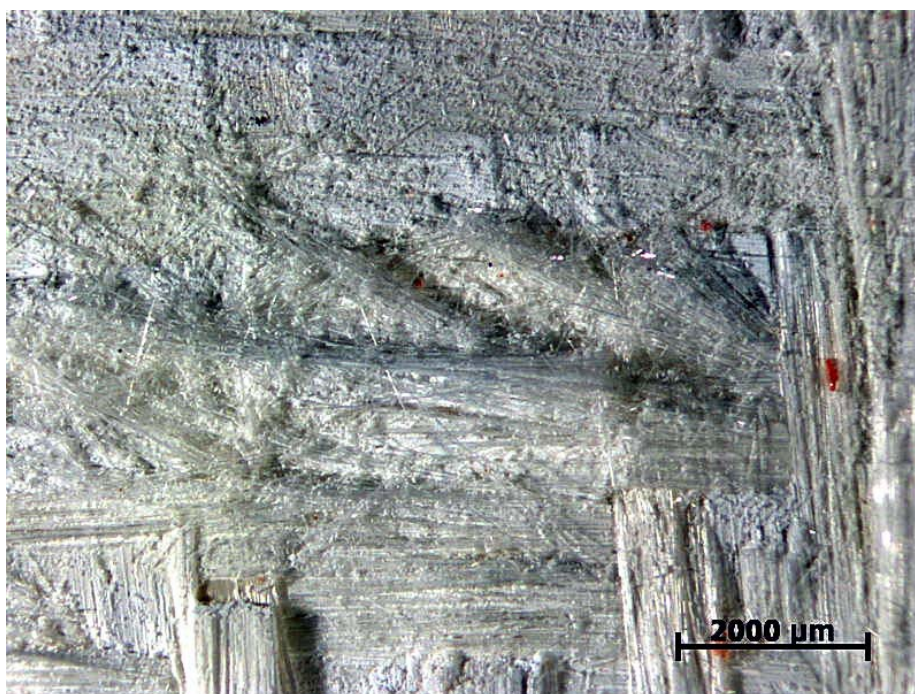
Figure 86: Close-up of piece B of the N720/A specimen tested in creep at -6.5 MPa at 1200 °C in air.

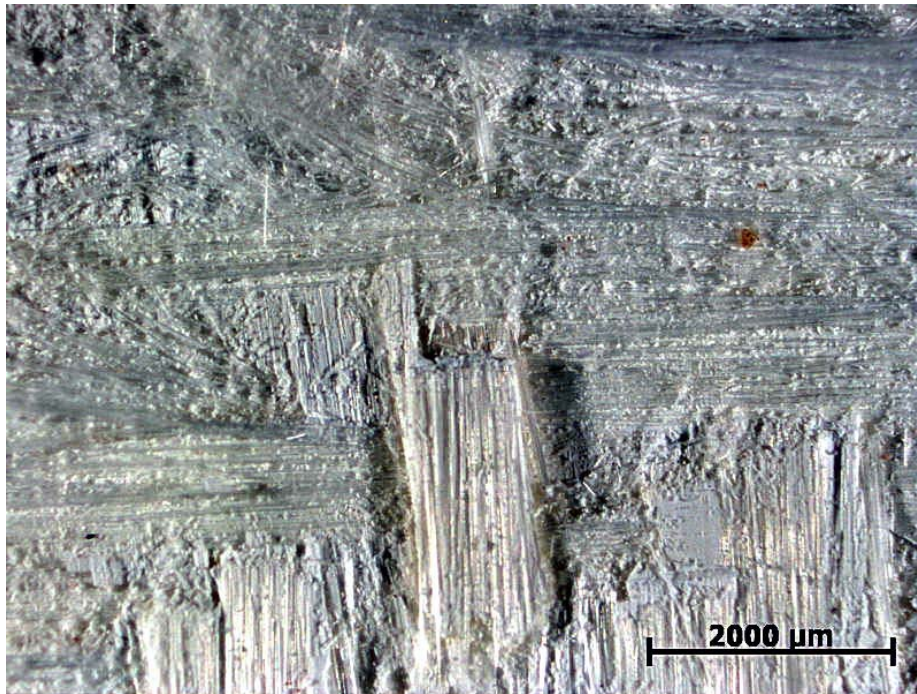
Figure 87: Close-up of piece B of the N720/A specimen tested in creep at -6.5 MPa at 1200 °C in air.

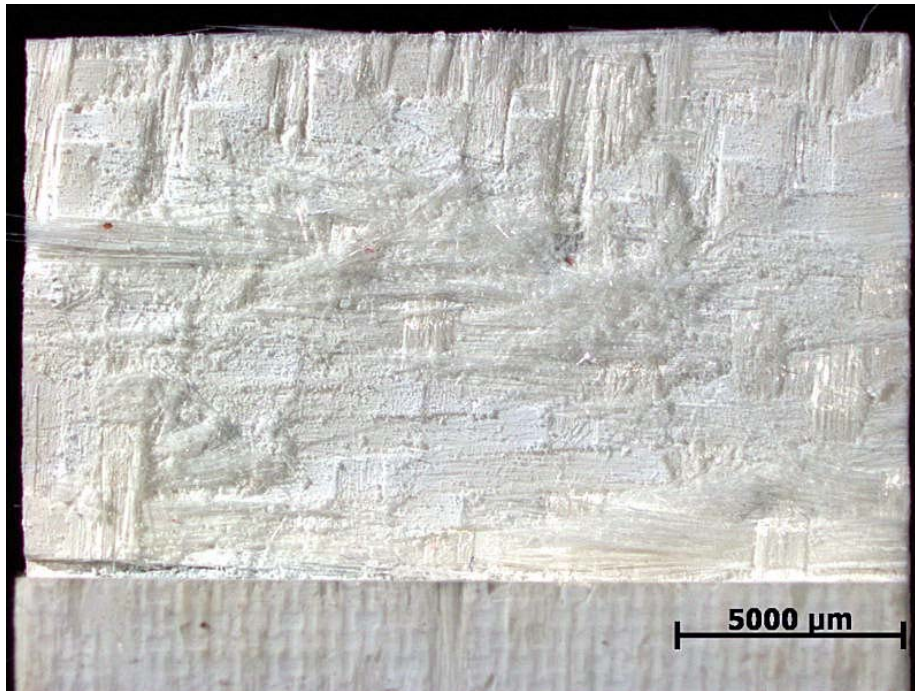
Figure 89: Fracture surface of the N720/A specimen not exposed to steam or 1200°C, Piece A.

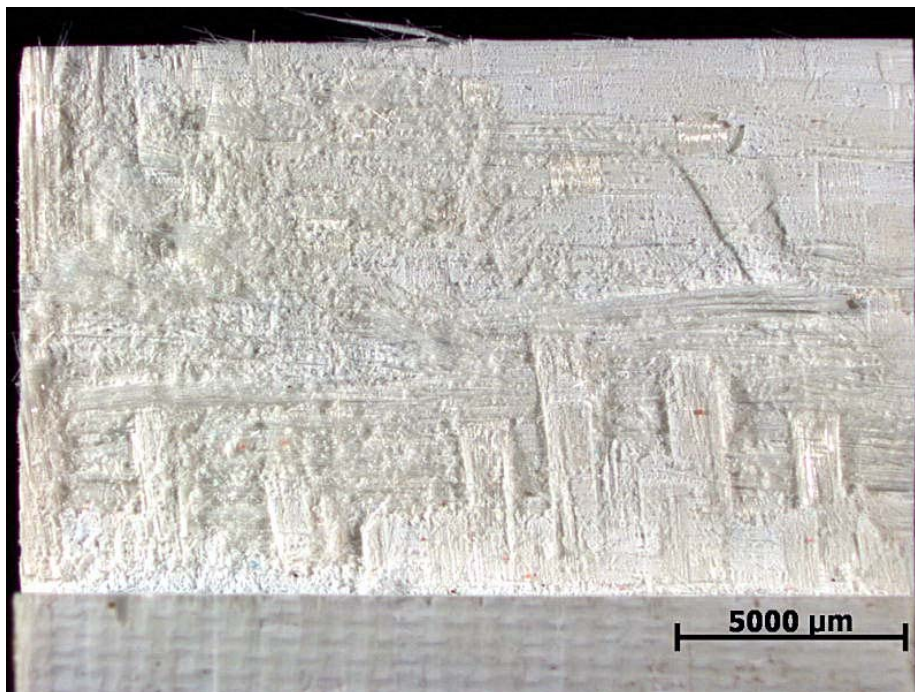
Figure 90: Fracture surface of the N720/A specimen not exposed to steam or 1200°C, Piece B.

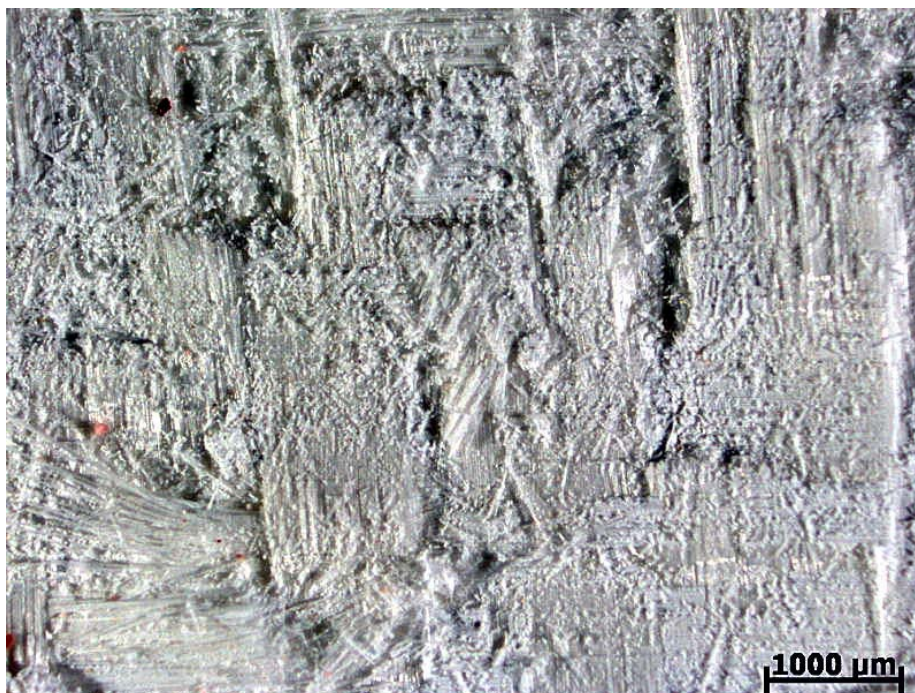
Figure 91: Close-up of piece A of the N720/A specimen tested in creep at -6.5 MPa at 1200 °C in steam.

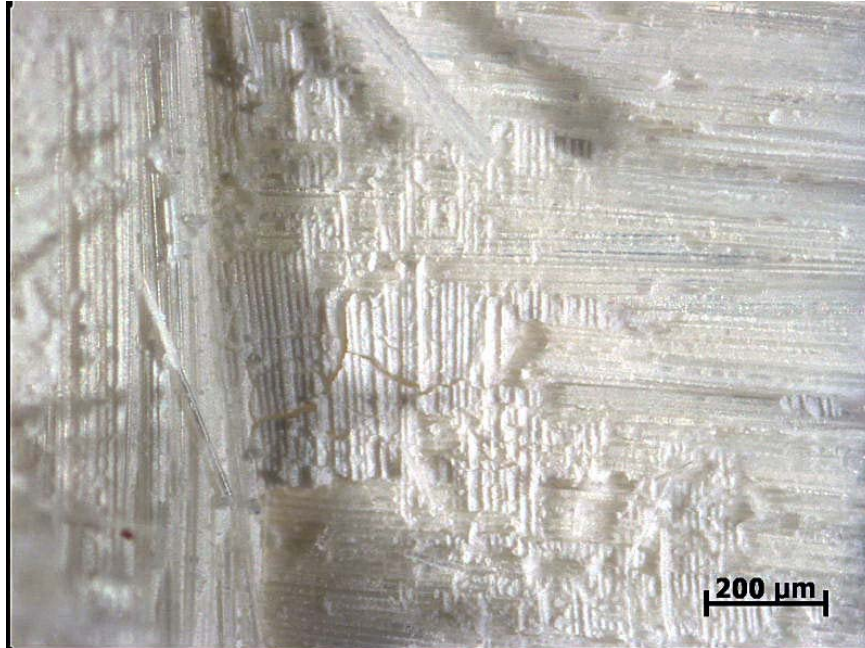
Figure 93: Close-up of piece A of the N720/A specimen tested in creep at -6.5 MPa at 1200 °C in steam.

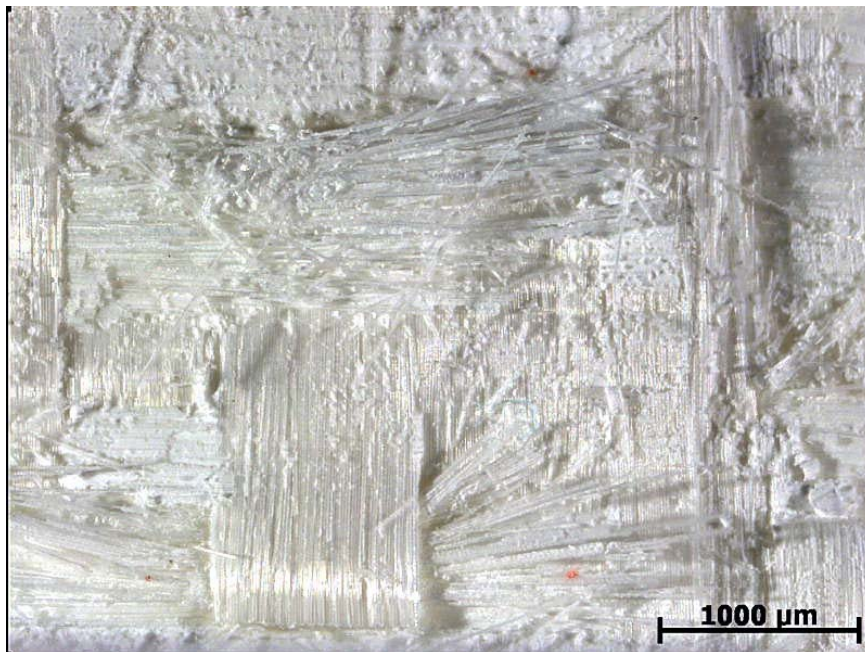
Figure 94: Close-up of piece A of the N720/A specimen tested in creep at -6.5 MPa at 1200 °C in steam.

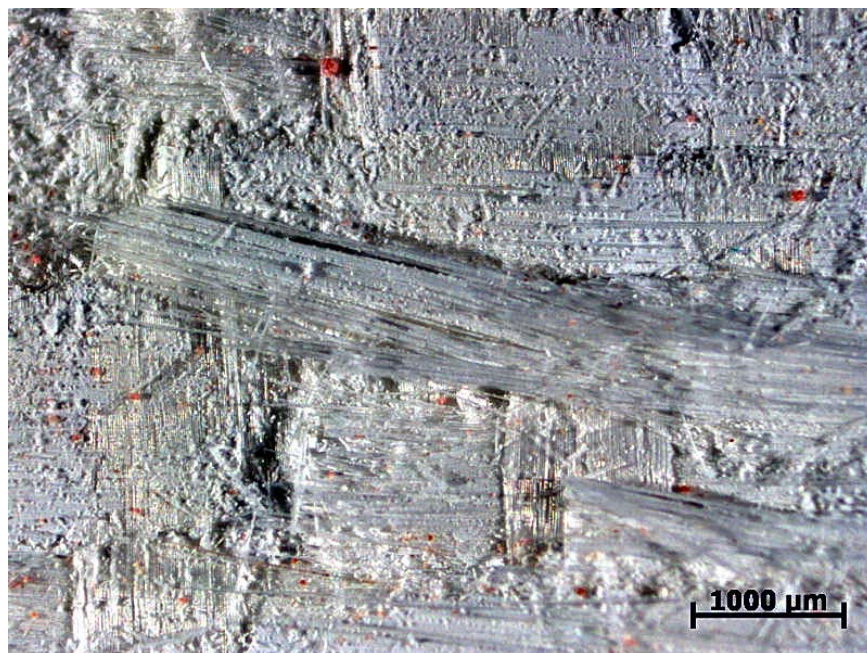
Figure 95: Close-up of piece A of the N720/A specimen tested in creep at -6.5 MPa at 1200 °C in steam.

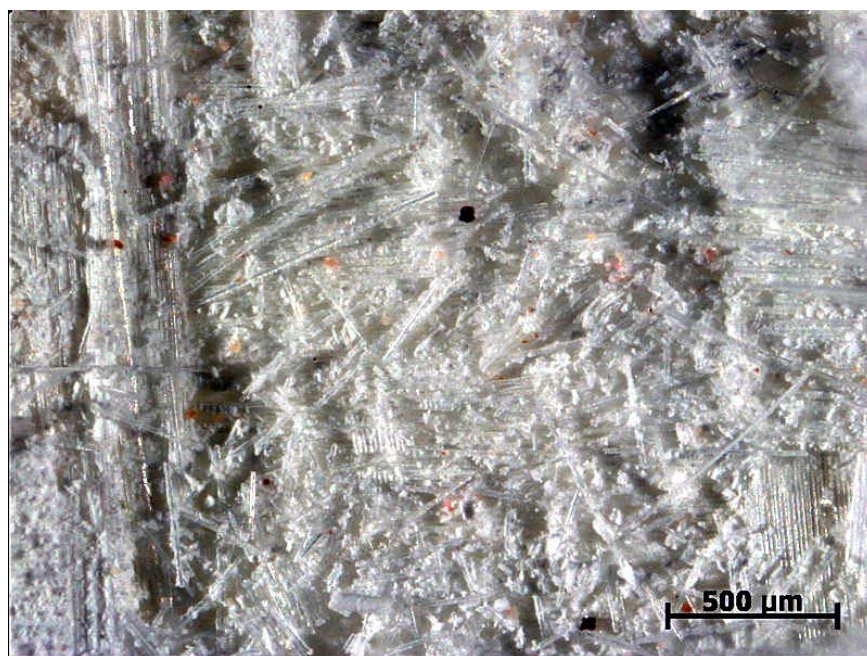
Figure 96: Close-up of piece A of the N720/A specimen tested in creep at -6.5 MPa at 1200 °C in steam.

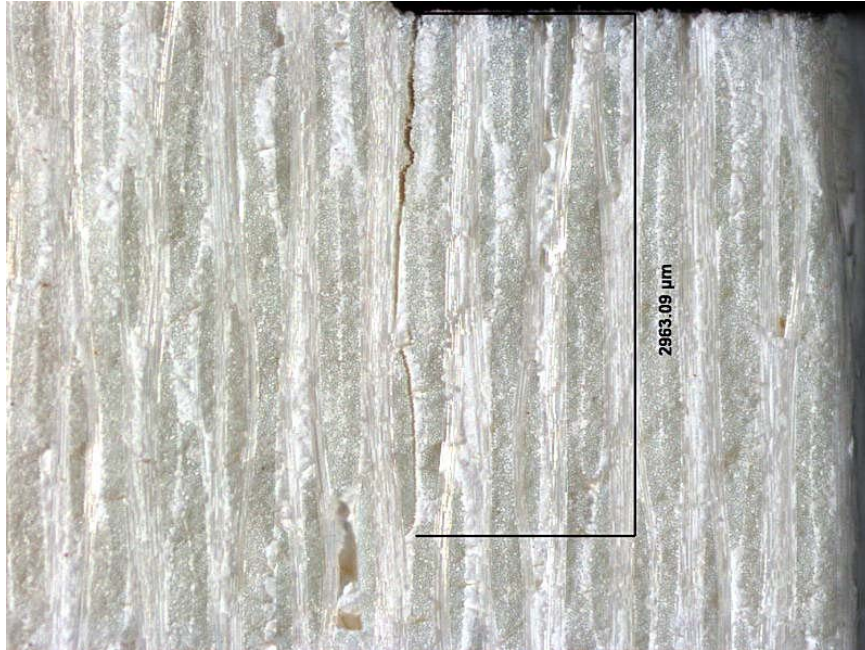
Figure 97: Close-up of the side of piece A of the N720/A specimen tested in creep at -6.5 MPa at 1200 °C in steam. The fracture extends into the specimen.

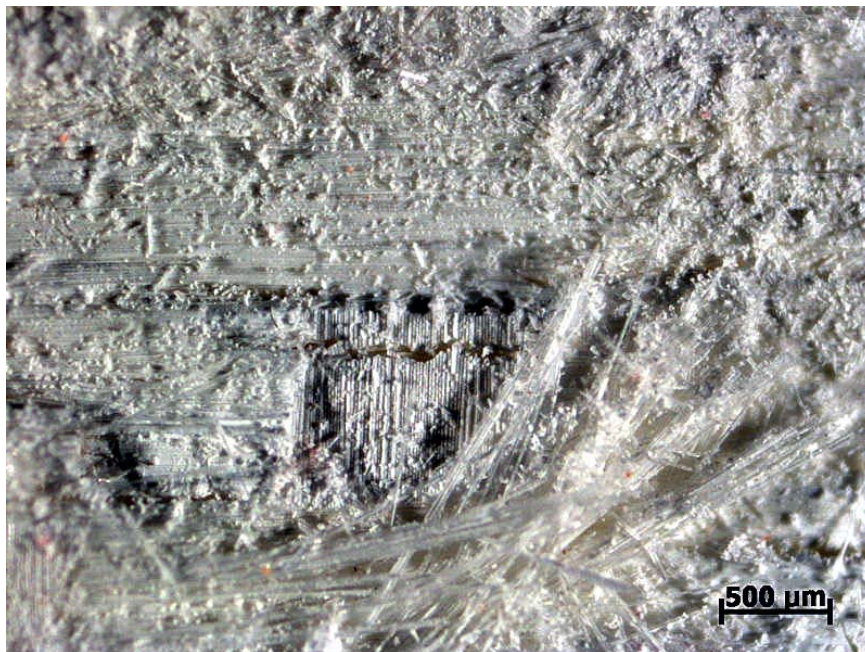
Figure 98: Close-up of piece A of the N720/A specimen tested in creep at -6.5 MPa at 1200 °C in steam.

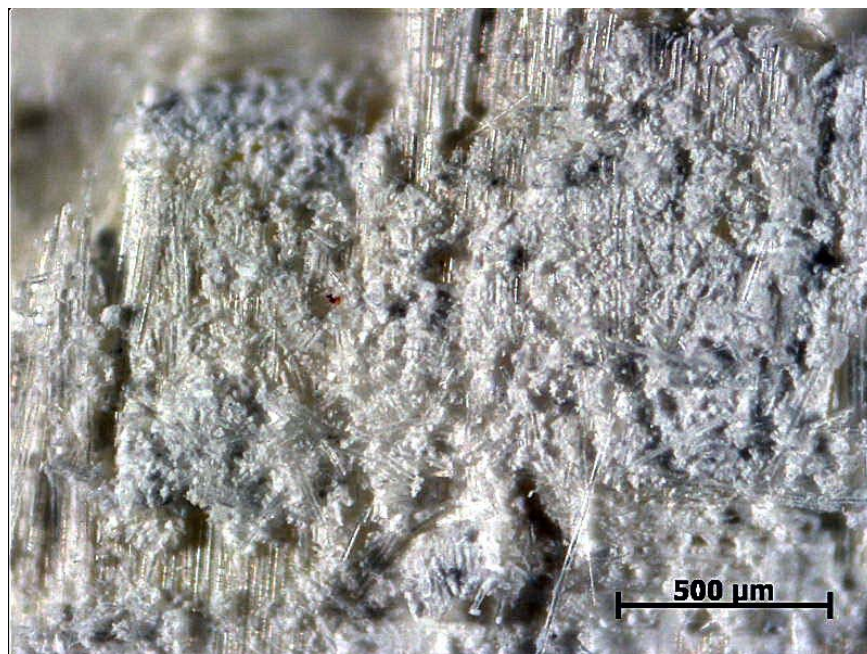
Figure 100: Close-up of piece A of the N720/A specimen tested in creep at -6.5 MPa at 1200 °C in steam.
